*M. Binkley, R. Madrak, K. Burkett, R. W. Wagner,*

On July 15, 2004 several wire samples were taken to the TD SEM in Lab 3. Donna Hicks and Deepak Chichili operated the equipment.

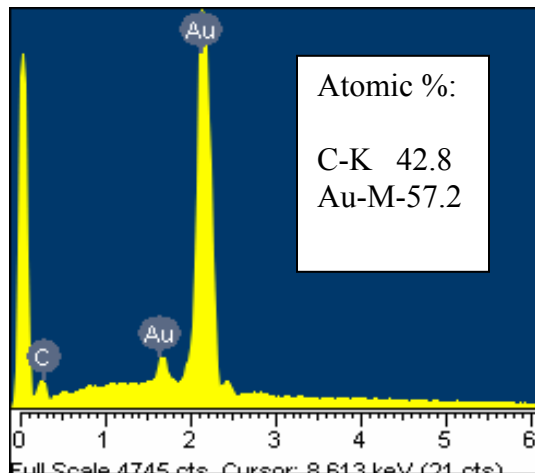
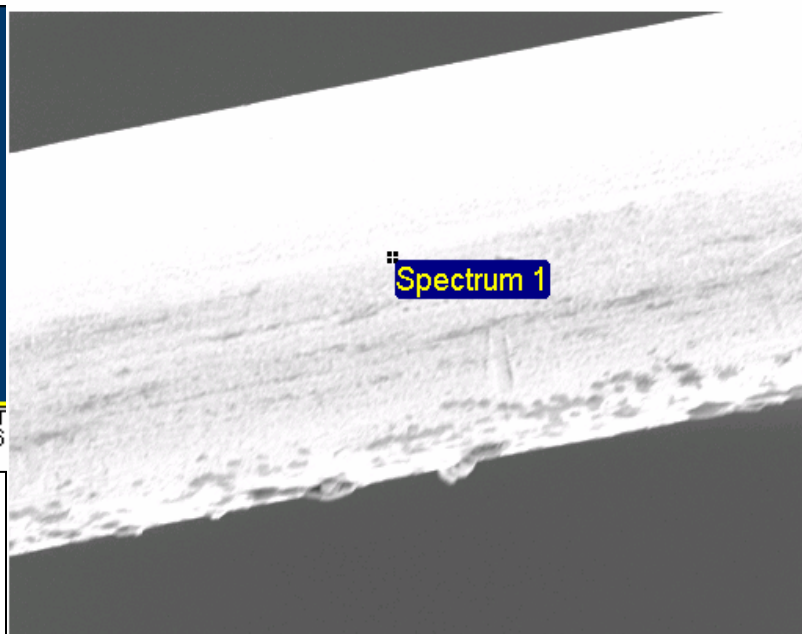
## New wire

EDS analysis of a new wire directly from the spool. The surface appears bright. Mostly gold is seen; the carbon appears to be background.

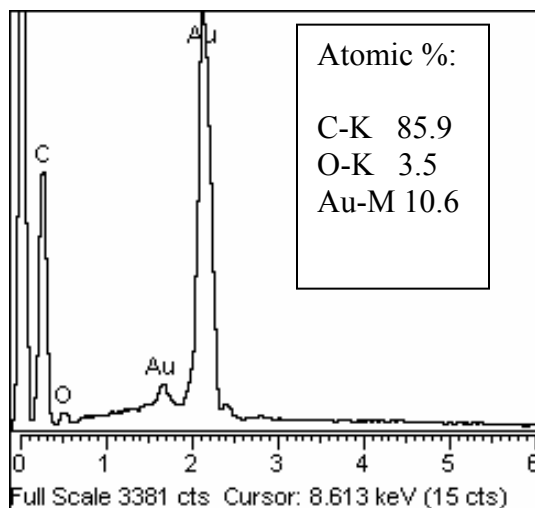
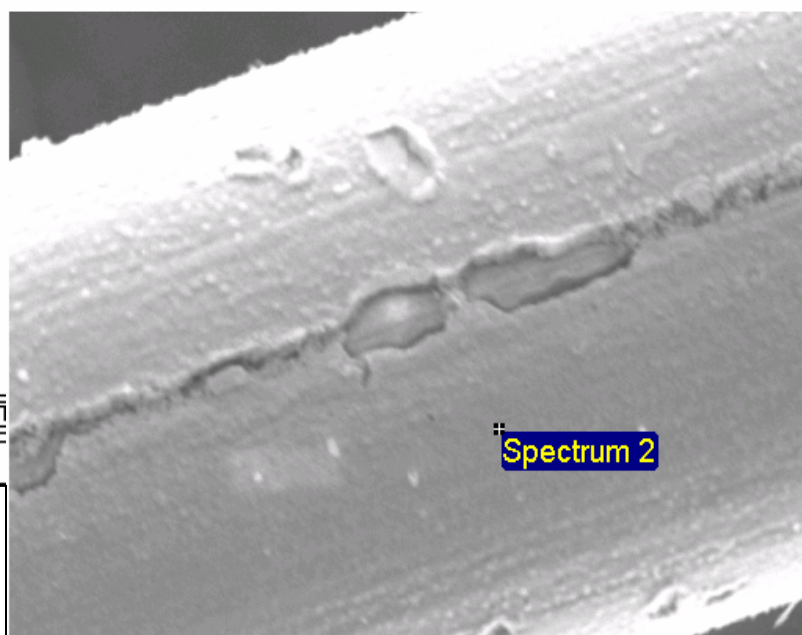
## Aged Wire general area

EDS analysis of the aged wire near the center in a general area. The surface is duller. Mostly carbon with a little gold and oxygen are seen.

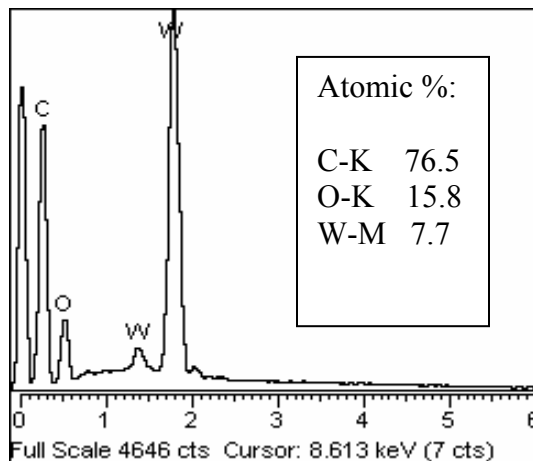
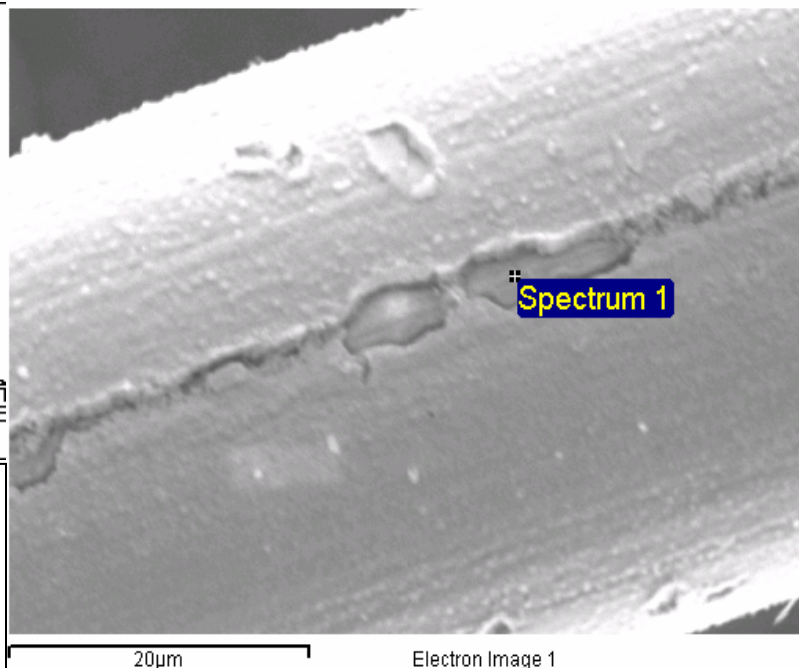
## Aged wire crater

EDS analysis of a crater near the center of the aged wire. Tungsten is seen instead of gold. The carbon polymer coating is still seen. Also the oxygen level is high (WO?).

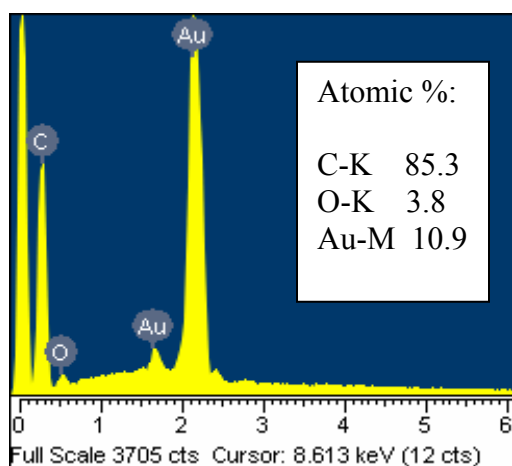
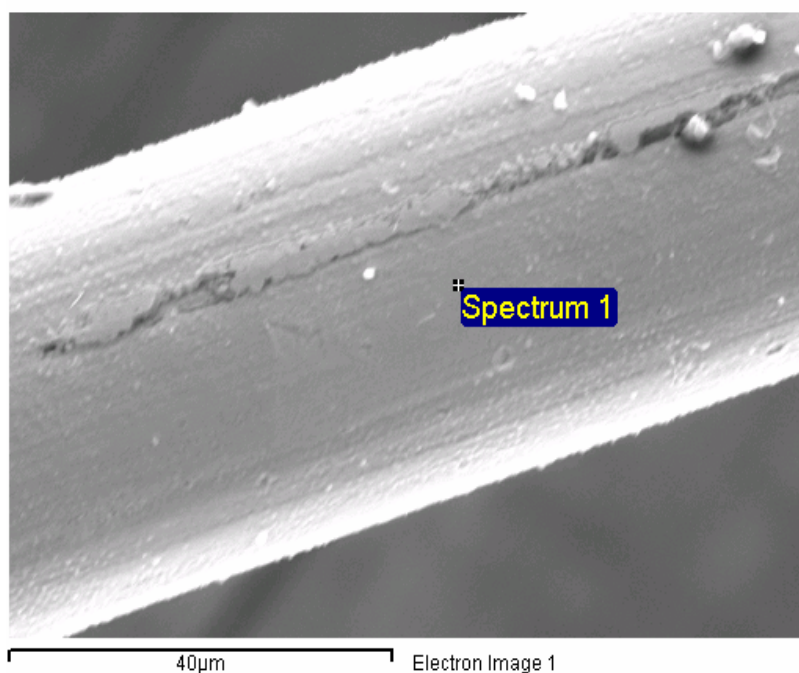
## Aged wire general area

EDS analysis of another general area on the aged wire near the center. Very similar to the previous general area on an aged wire,

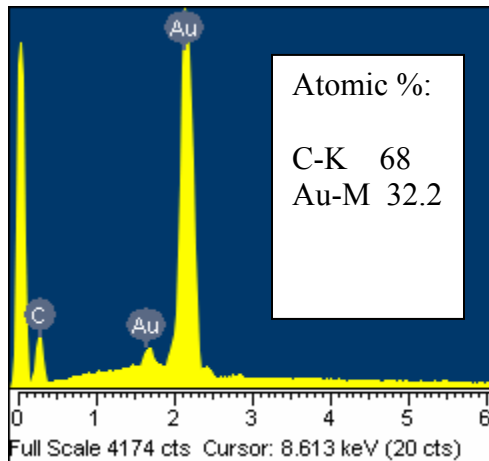
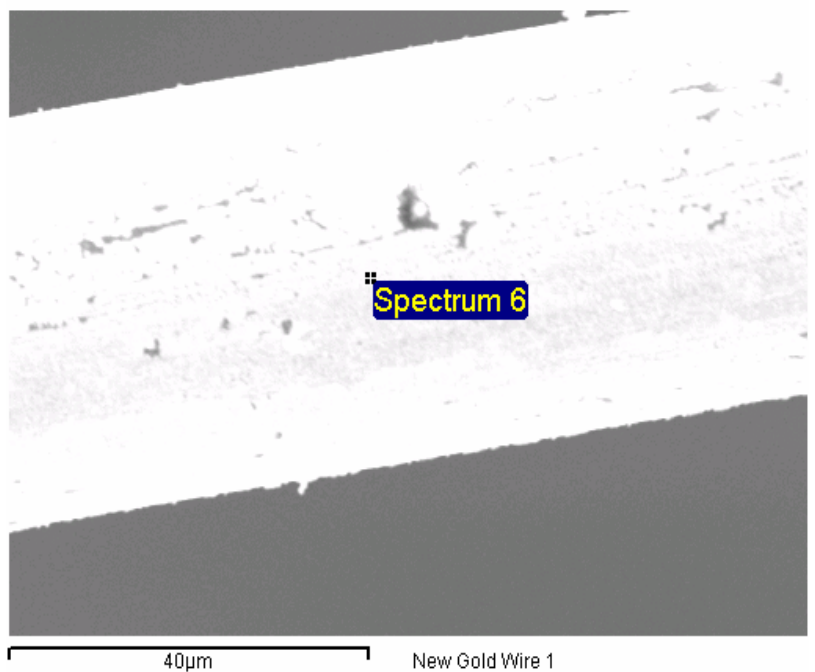
### Reverse aged in SS tube at center.

EDS analysis of the wire reverse aged in SS tube with COT exhaust gas (~100ppm of O<sub>2</sub>). Surface brighter than aged wire, but more carbon than on new

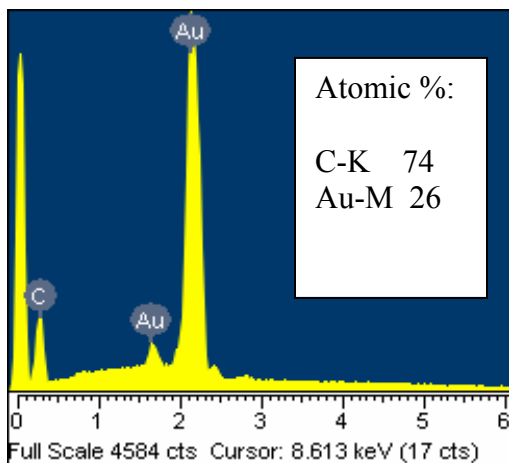
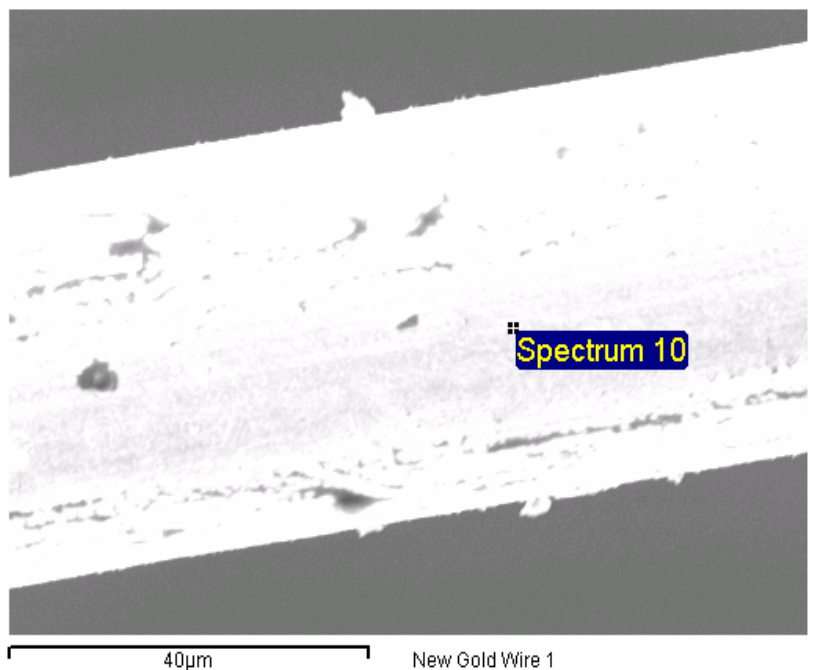
### Reverse aged in SS tube at center.

EDS analysis of the wire reverse aged in SS tube with COT chamber exhaust. Wire surface looks brighter than age wire, but more carbon seen than on new wire.

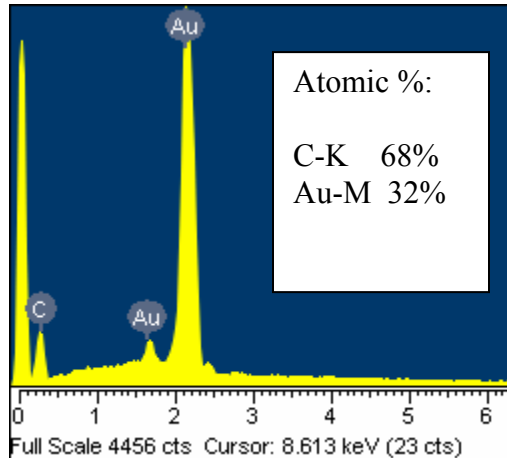
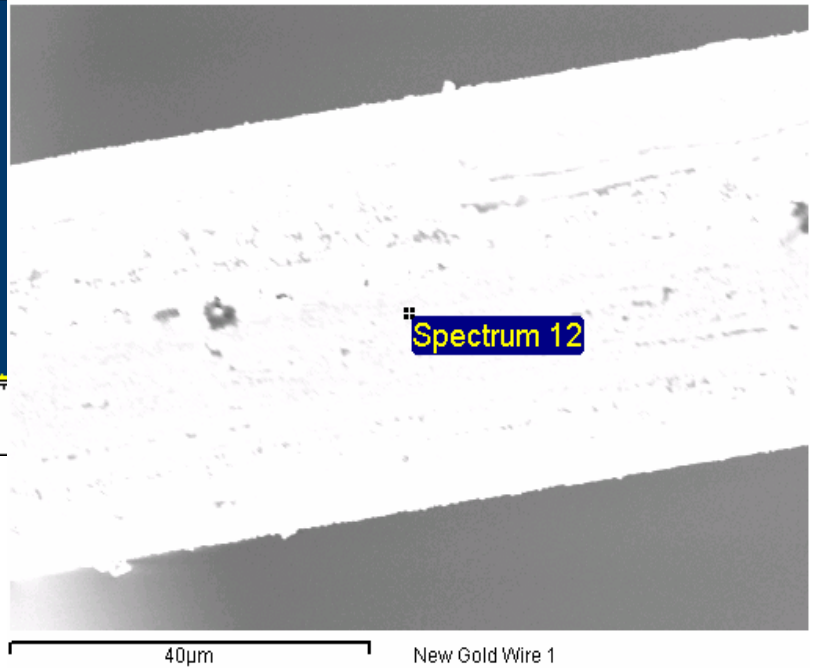
### Reverse aged in SS tube 6mm right of center.

EDS analysis of the wire reverse aged in the SS tube chamber with COT exhaust gas. Wire surface looks brighter than aged wire, but more carbon than new wire.

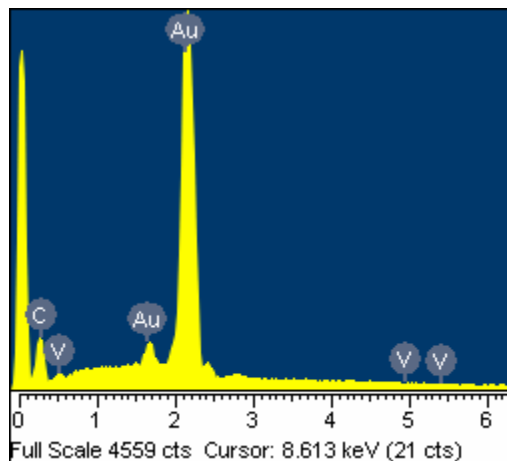
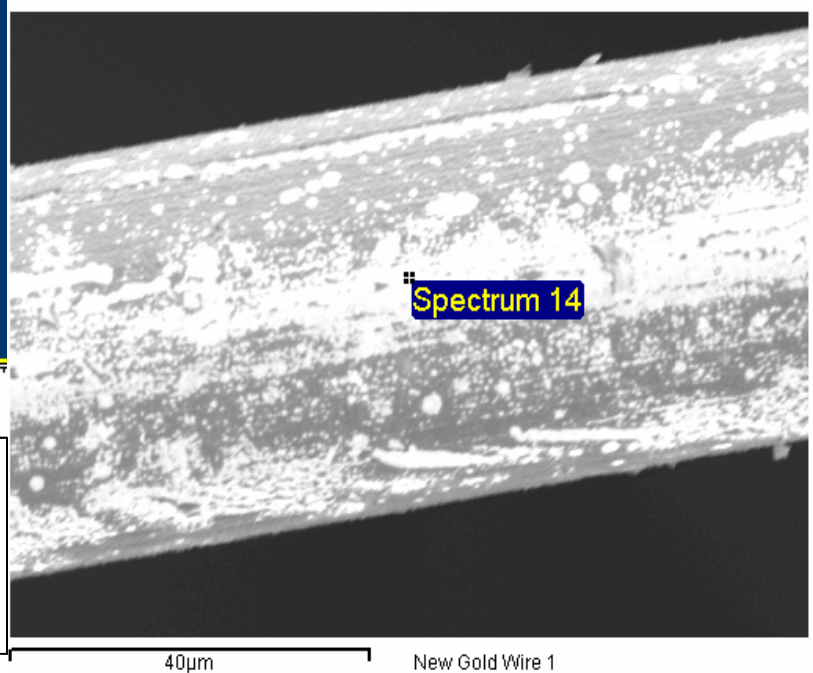
### Reverse aged in SS tube 20mm right of center

EDS analysis of the wire reverse aged in the SS tube 20mm from the center. There are bright and dark areas on the surface. Analysis of the bright area shows less carbon.

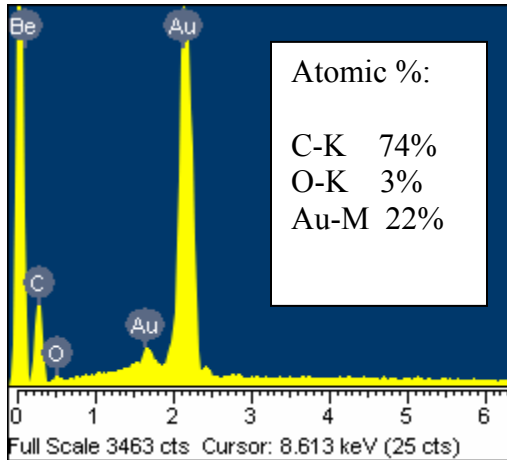
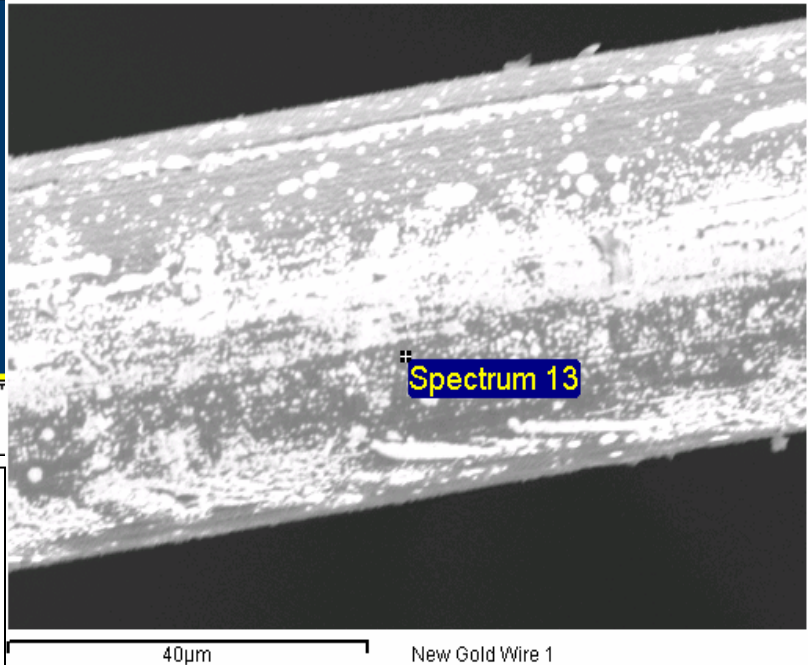
### Reverse aged in SS tube 20mm right of center

EDS analysis of the wire reverse aged in the SS tube 20mm from the center. The bright areas have been reverse aged more. The analysis of the dark area shows more carbon.

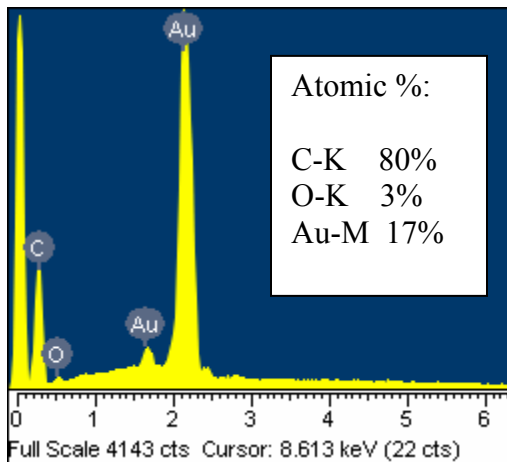
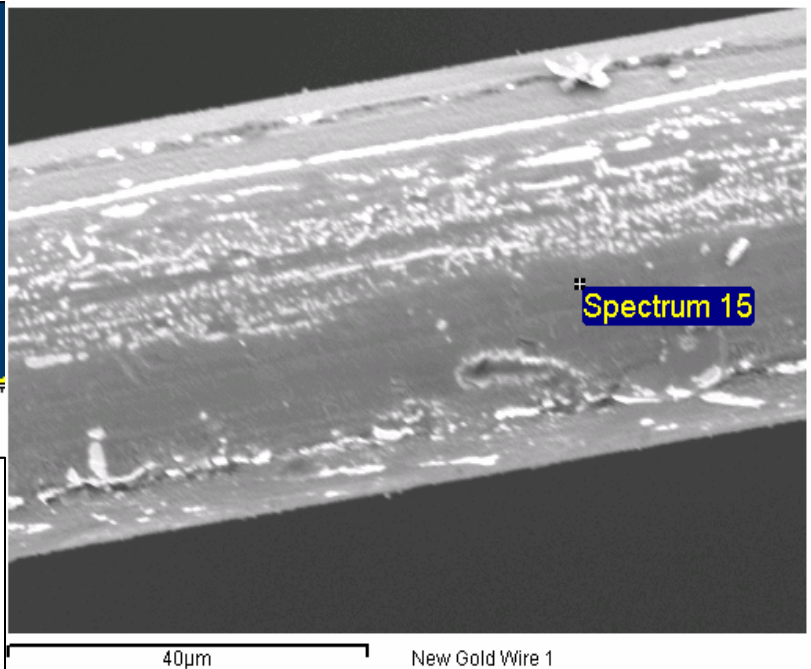
### Reverse aged in SS tube 30mm right of center

EDS analysis of the wire reverse aged in the SS tube 30mm from the center. The wire is mostly dark indicating more coating. Analysis shows more carbon than at 20mm.

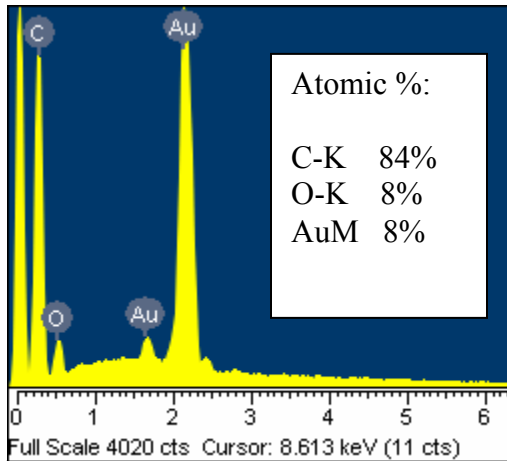
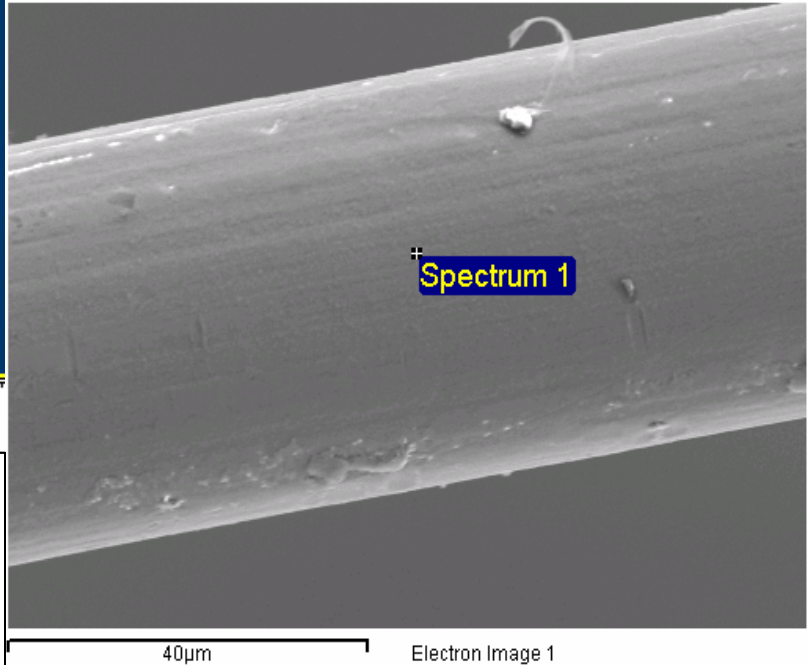
## GMC wire with more aging shown at its center

EDS analysis of the wire away from the source in the GMC that was additionally aged. The coating is dark and the carbon and oxygen levels are high.

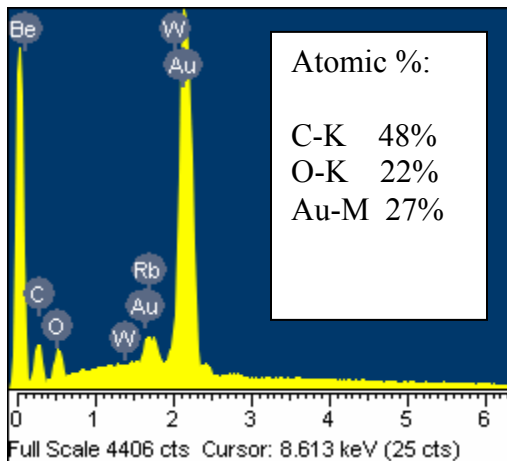
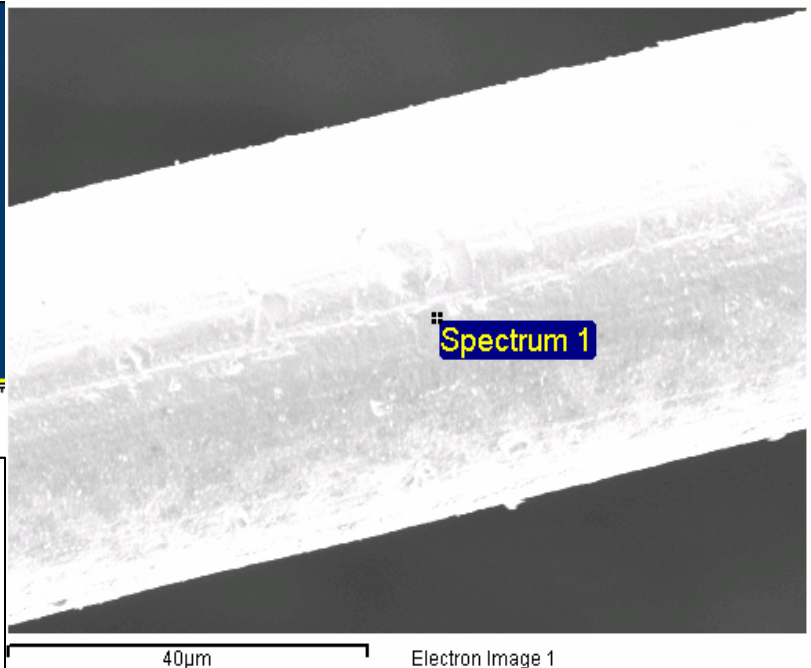
## Reverse aged GMC wire at the center (avg2)

EDS analysis of the wire reverse aged in the GMC (Ar/CO<sub>2</sub>) at the center. The surface is bright and the carbon level is relatively low, but the oxygen level is higher.

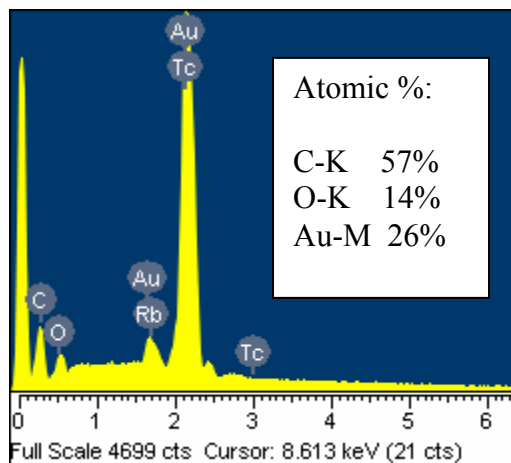
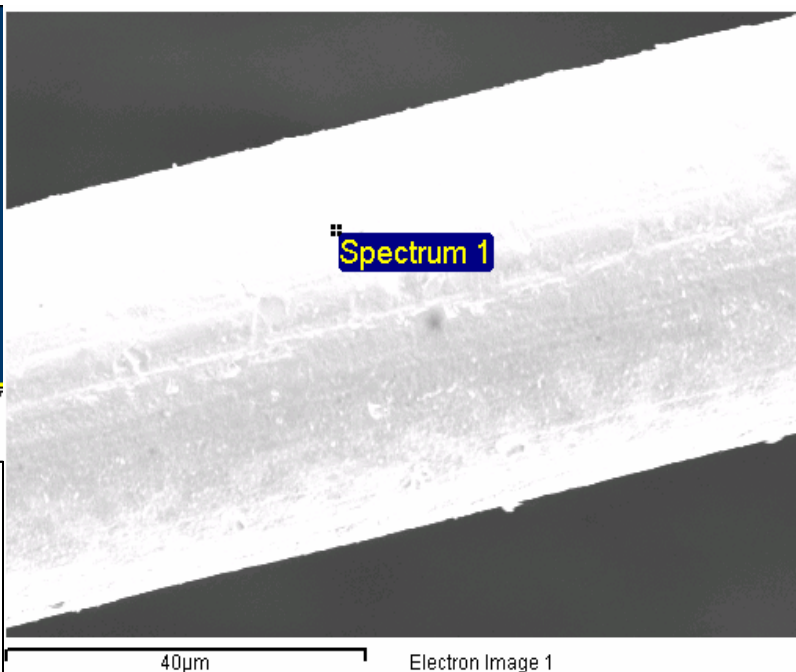
### Reverse aged GMC wire at the center (avg3)

EDS analysis of the wire reverse aged in the GMC (Ar/CO<sub>2</sub>) at the center. Similar to above, but a little less oxygen. Possible traces of Rb and Tc at the 1% level.

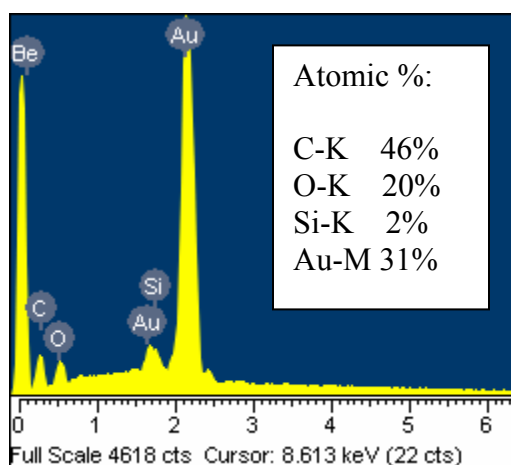
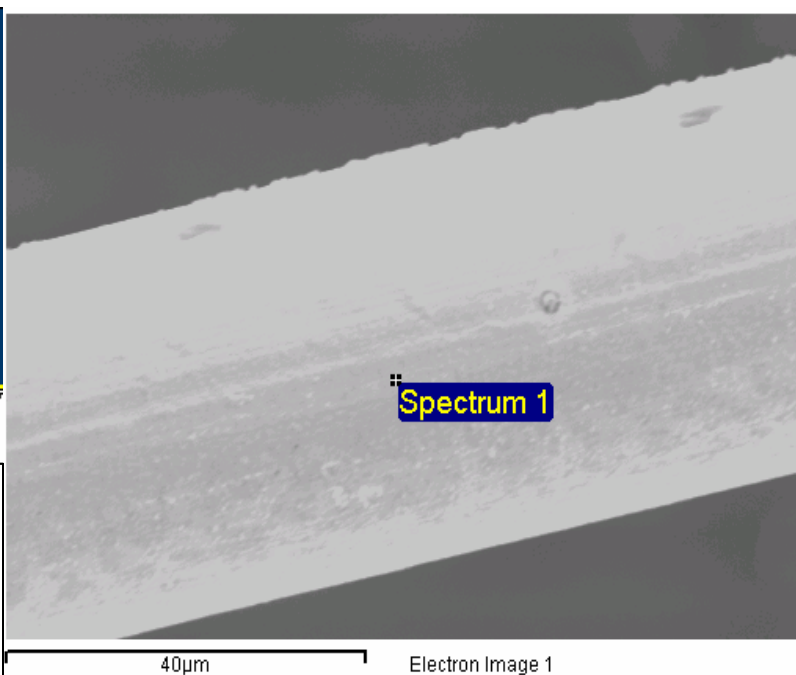
### Reverse aged GMC wire at the center (avg)

EDS analysis of the wire reverse aged in the GMC (Ar/CO<sub>2</sub>) at the center. Similar to the previous two, More oxygen and less carbon than for the wire reverse aged in the SS tube.

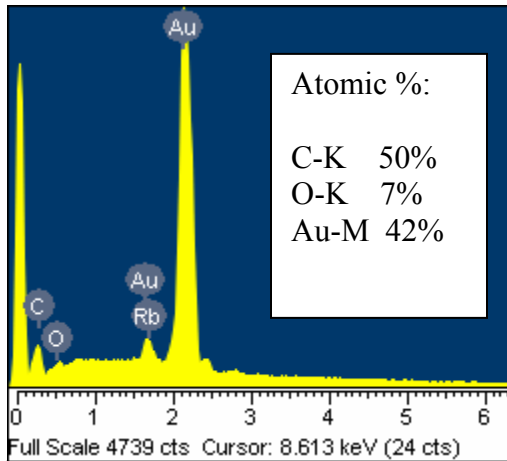
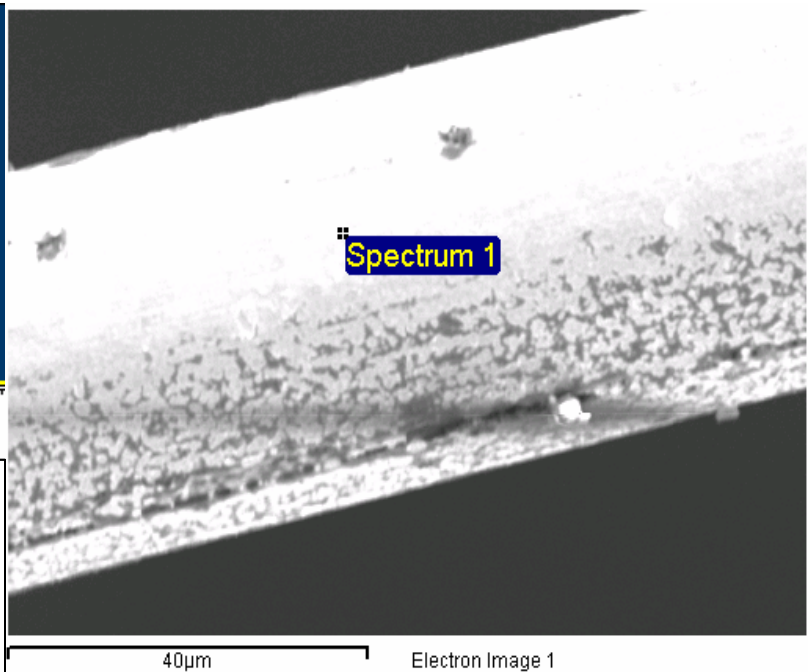
## Wire reverse aged in GMC to the left of center

EDS analysis of wire reverse aged in the GMC (Ar/CO<sub>2</sub>) to the left of center. There are darker areas on the wire but the bright spot that was analyzed shows very little carbon.

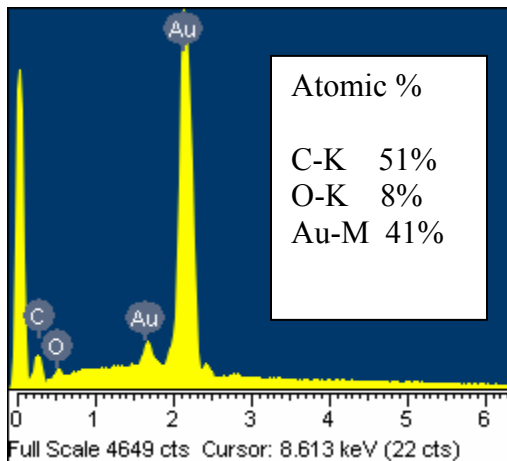
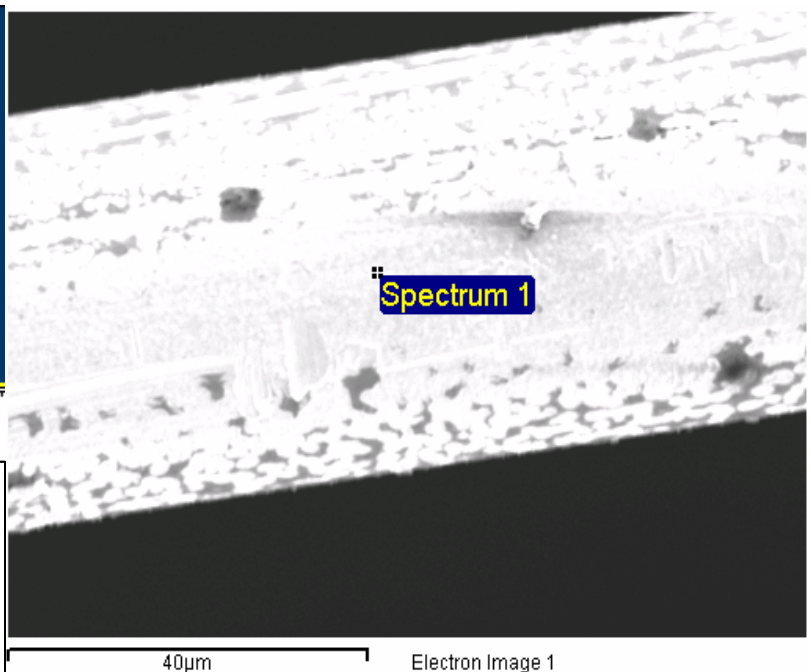
## Wire reverse aged in GMC to the right of center

EDS analysis of wire reverse aged in the GMC (Ar/CO<sub>2</sub>) to the right of center. The surface is in general bright with some dark areas. Again carbon levels low, but oxygen levels may be a little higher.

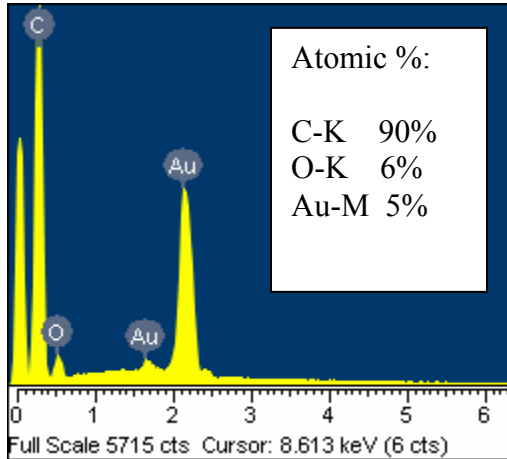
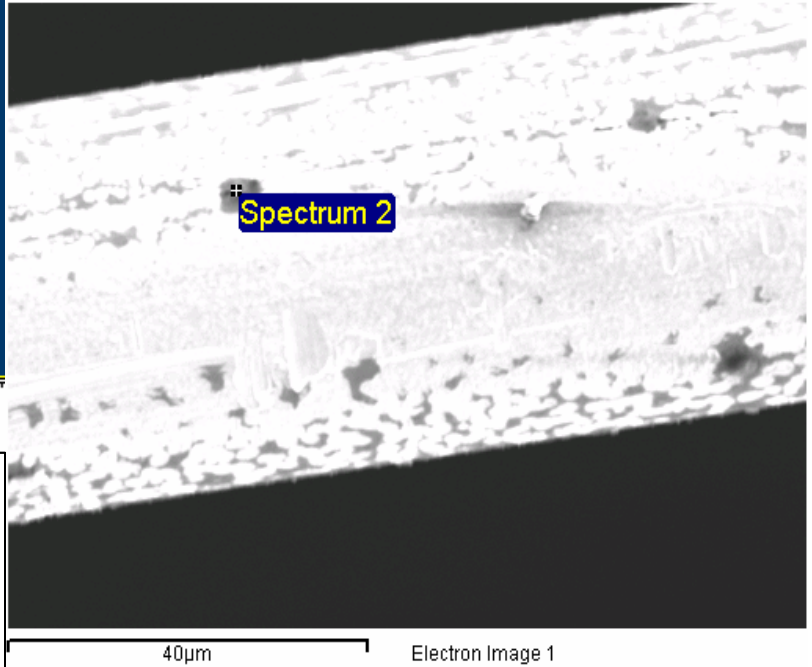
## Dark spot to the right of center on wire reverse aged in GMC

EDS analysis of dark spot to the right of center on wire reverse aged in GMC (Ar/CO<sub>2</sub>). This spot is very near the bright area analyzed above. The carbon level is very high.
